Thermographic Roof Survey

Sample Report

Pixel Thermographics Ltd

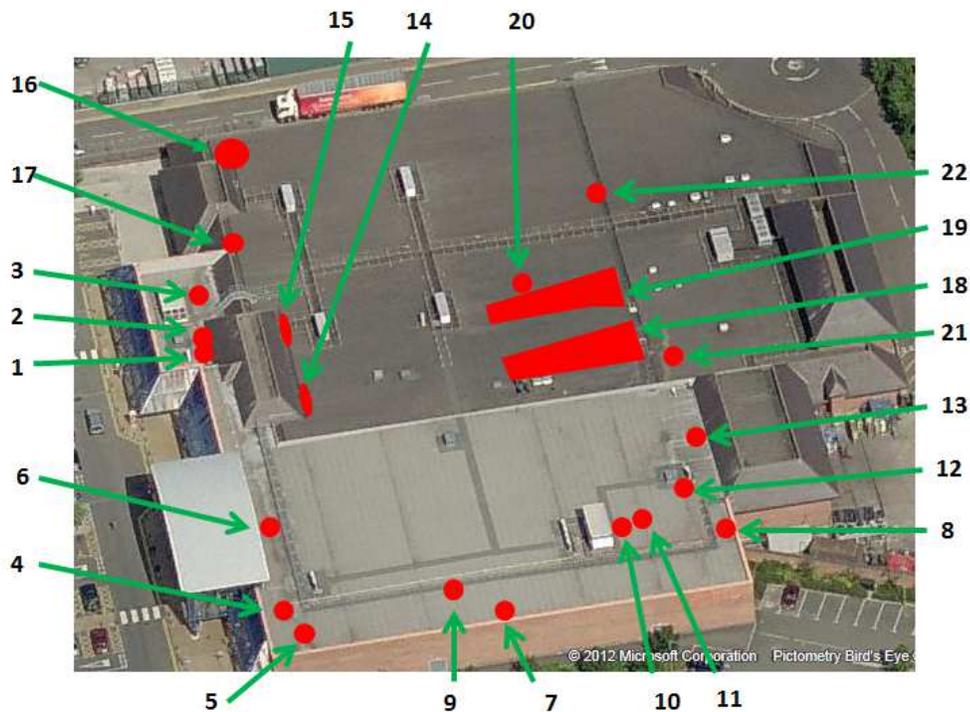
The survey has highlighted 22 leak locations on the roof. The image below shows the locations of the leaks on the roof systems

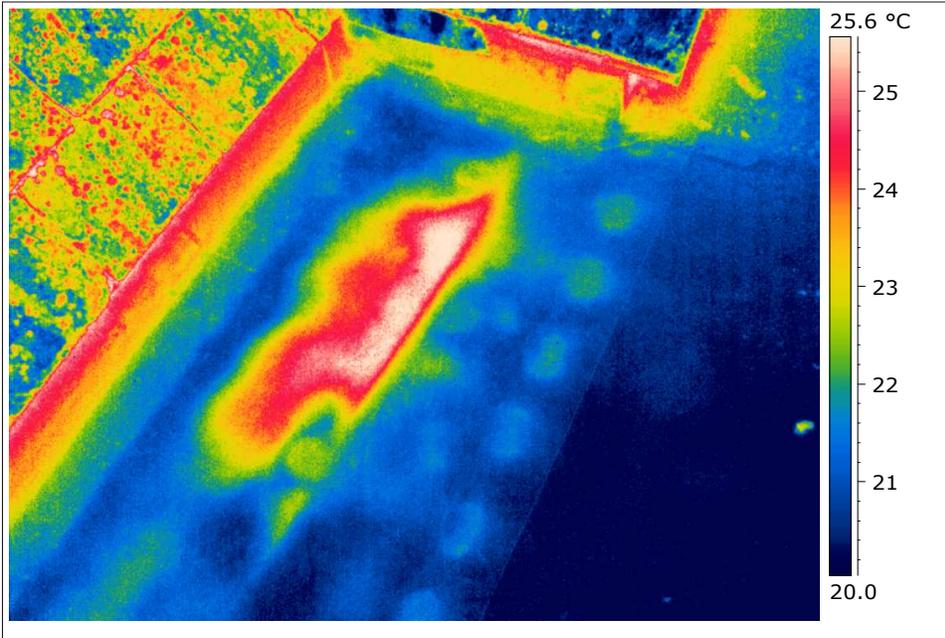
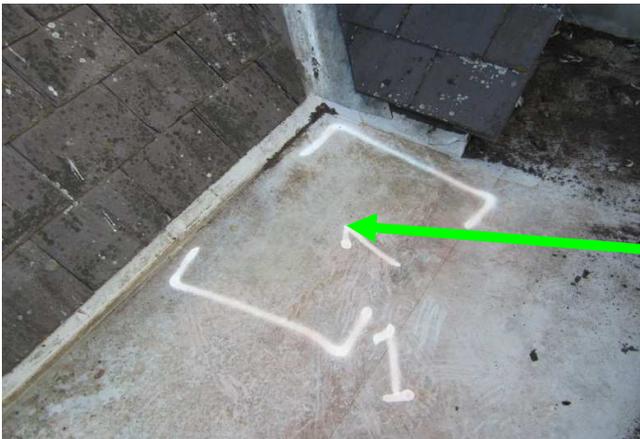
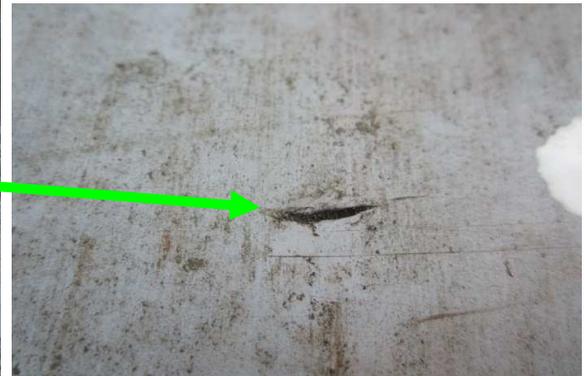
Area: Leak Number 1

The irregular shaped warm area indicates water ingress within the roof system. Closer visual inspection revealed a puncture in the membrane (arrowed) which is the likely entry point for moisture and should be repaired.

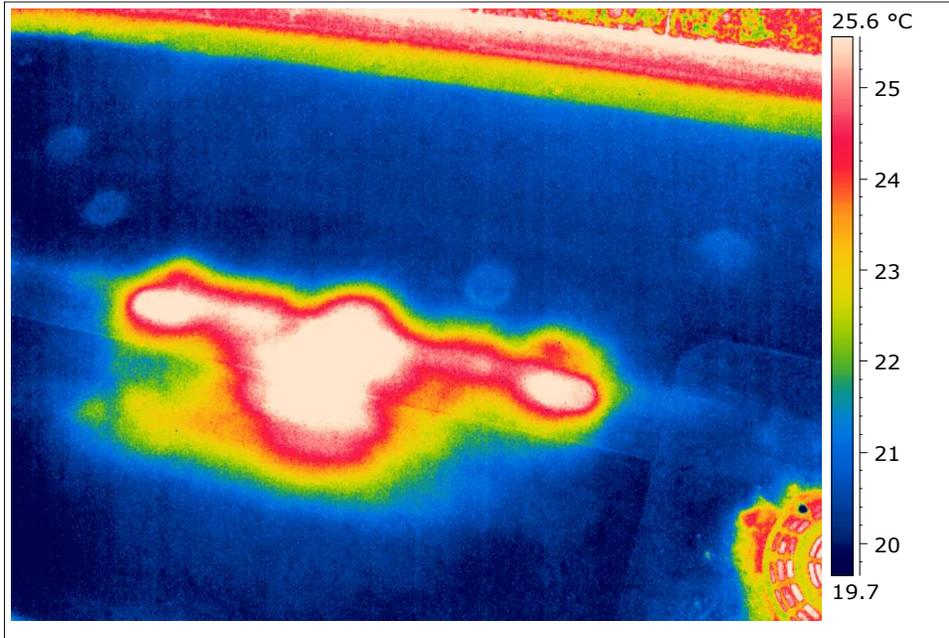
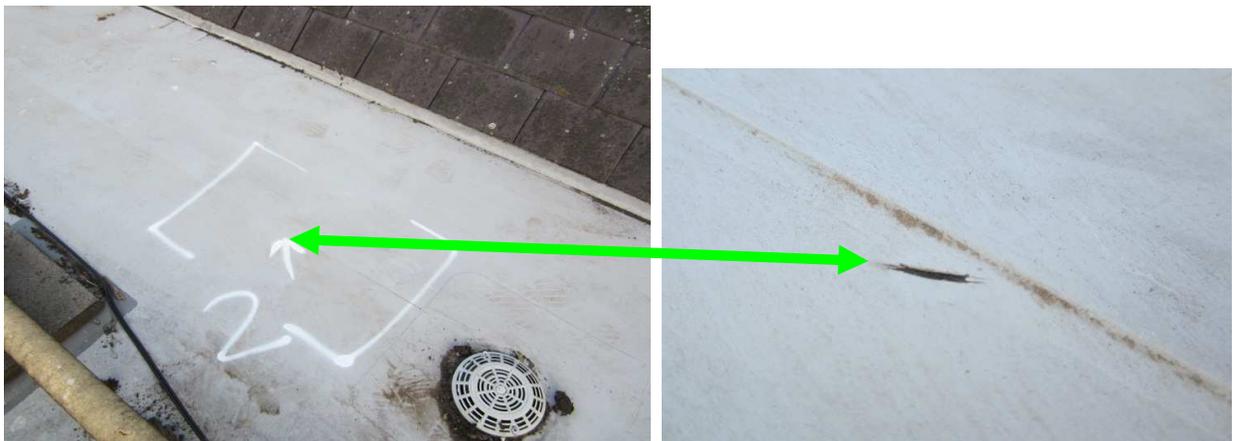
Area: Leak Number 2

The irregular shaped warm area indicates water ingress within the roof system. Closer visual inspection revealed a slit in the membrane (arrowed) which is the likely entry point for moisture and should be repaired.

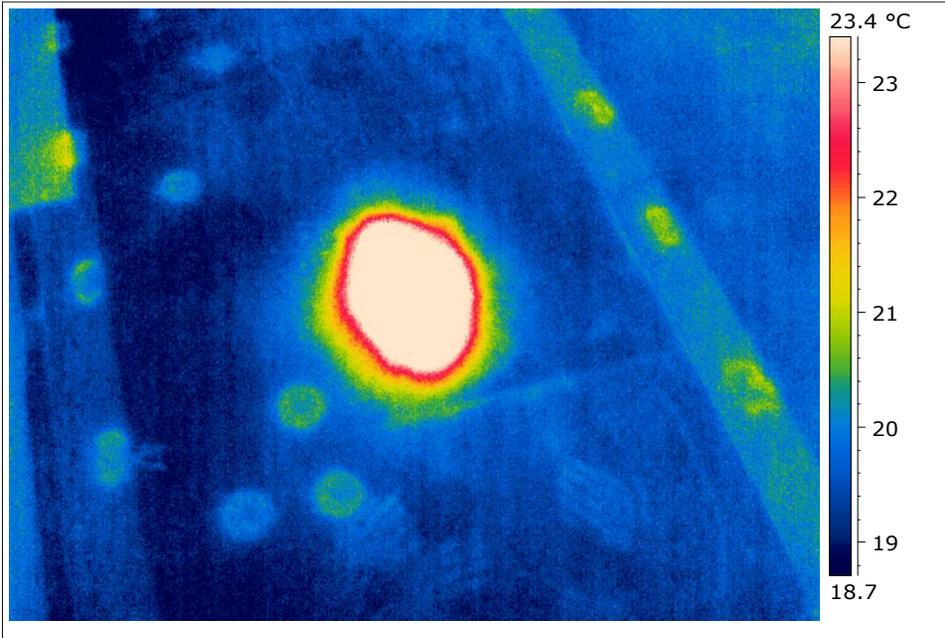
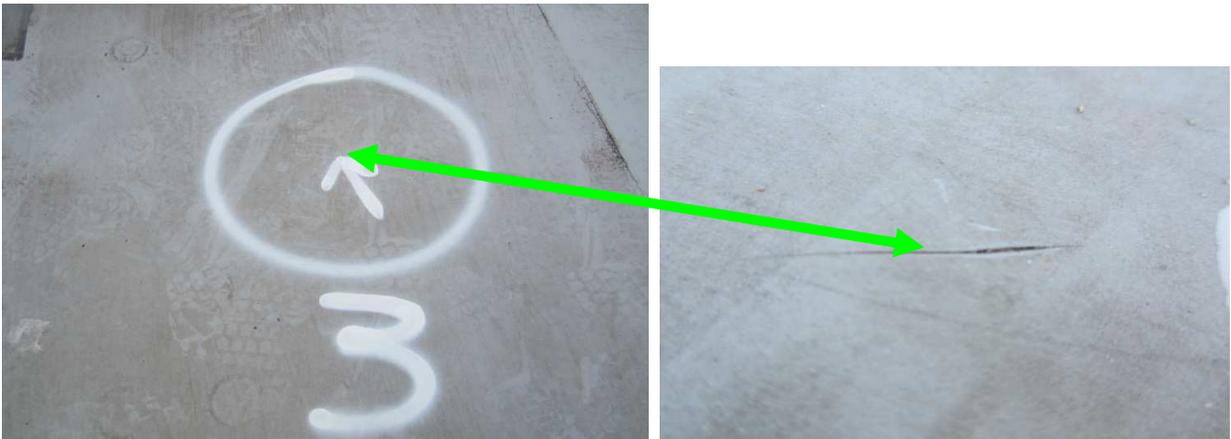
Area: Leak Number 3

The irregular shaped warm area indicates water ingress within the roof system. Closer visual inspection revealed a slit in the membrane (arrowed) which is the likely entry point for moisture and should be repaired.

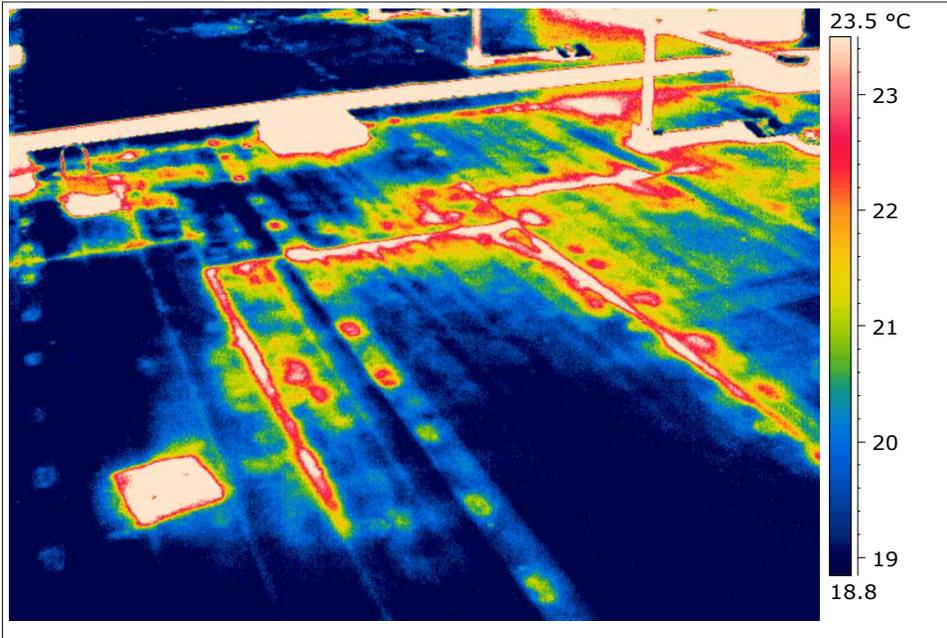
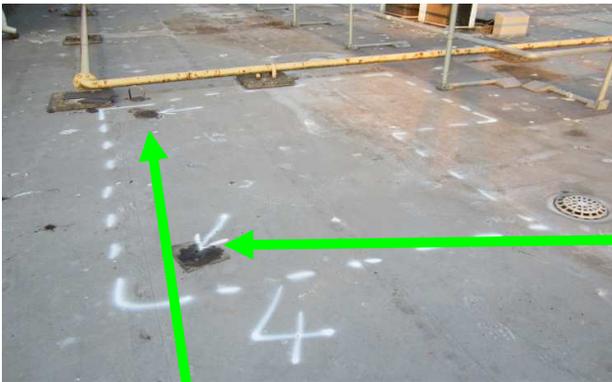
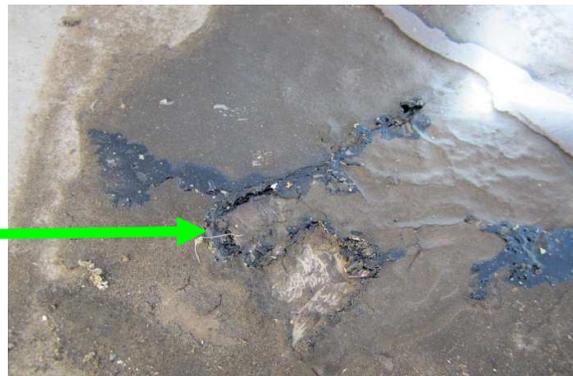
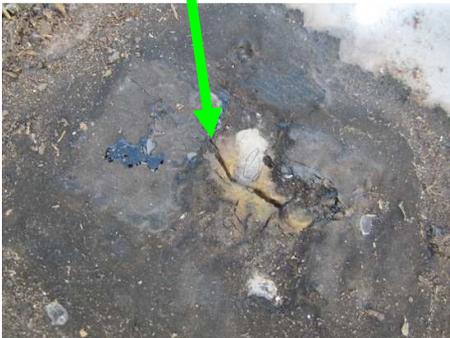
Area: Leak Number 4

The irregular shaped warm areas indicate water ingress within the roof system. Closer visual inspection revealed 2 punctures in the membrane (arrowed) which are the likely entry points for moisture and should be repaired. These areas appear to have been attempted to be repaired previously but the standard appears very poor and were concealed by slate tiles.

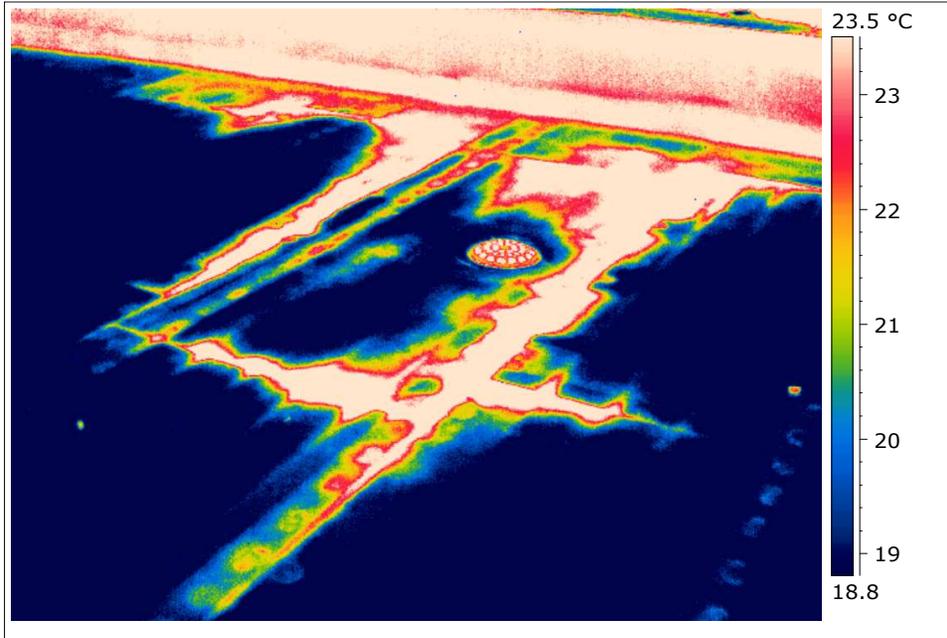
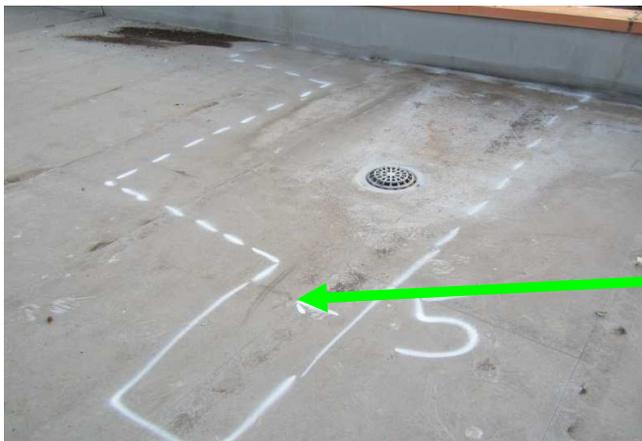
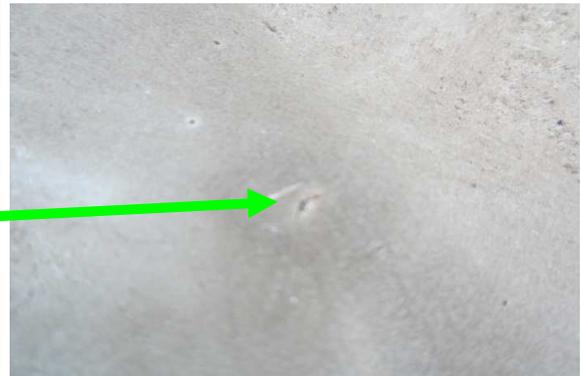
Area: Leak Number 5

The irregular shaped warm area indicates water ingress within the roof system. Closer visual inspection revealed a penetration in the membrane (arrowed) which is a possible entry point for moisture and should be repaired. It is also possible that water ingress from leak number 4 (see previous page) could be tracking and gathering in this area.

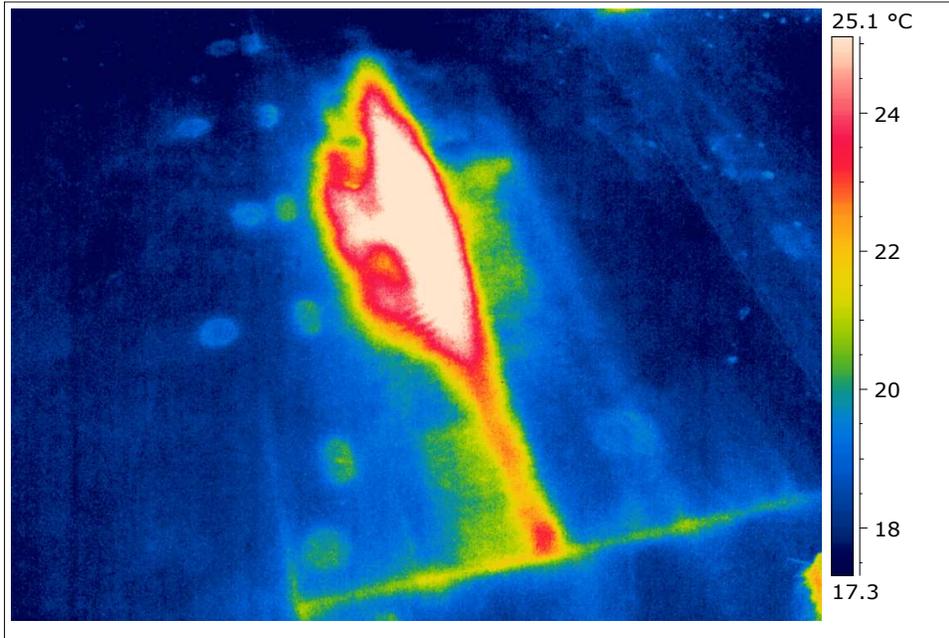
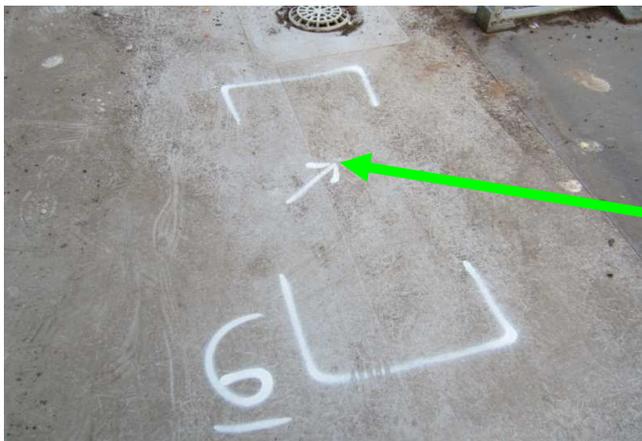
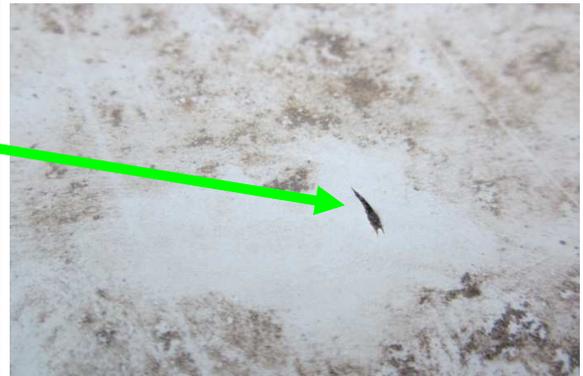
Area: Leak Number 6

The irregular shaped warm area indicates water ingress within the roof system.

Closer visual inspection revealed a penetration in the membrane (arrowed) which is the likely entry point for moisture and should be repaired.

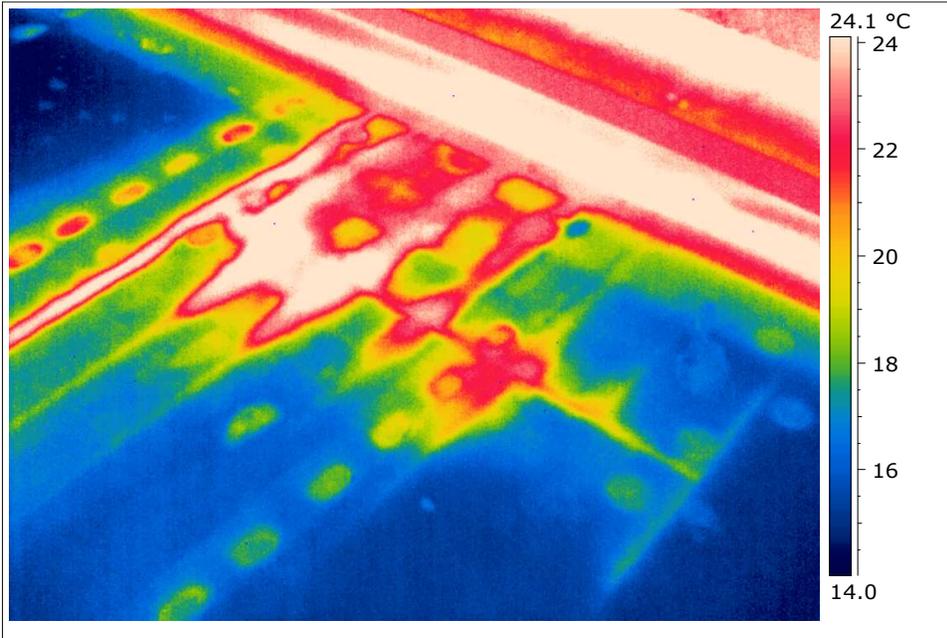
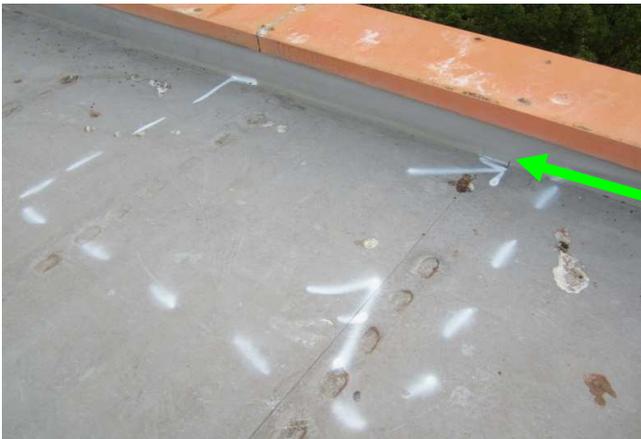
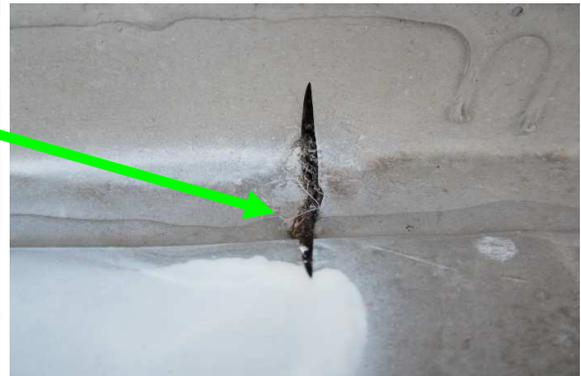
Area: Leak Number 7

The irregular shaped warm area indicates water ingress within the roof system. Closer visual inspection revealed a slit in the membrane (arrowed) which is the likely entry point for moisture and should be repaired.

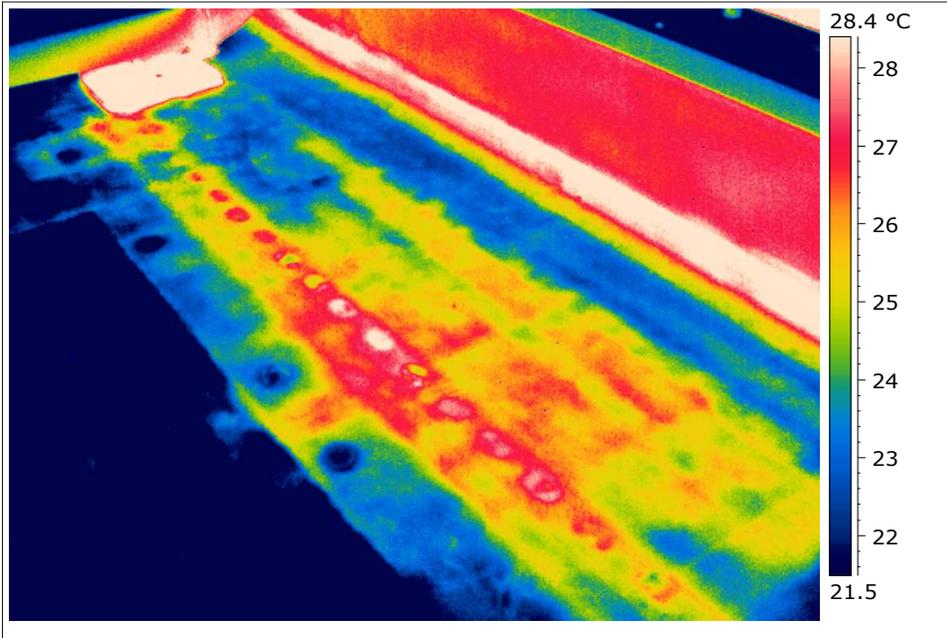
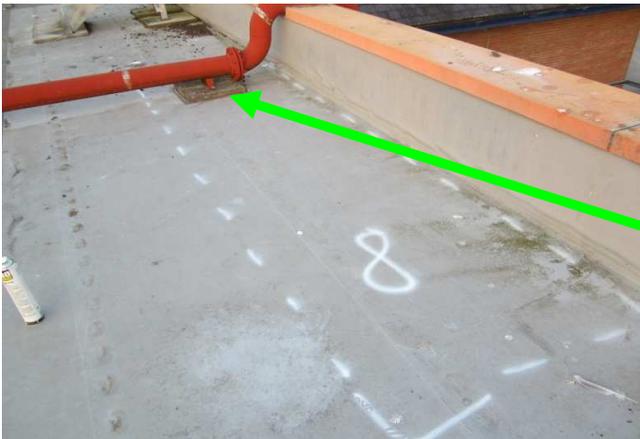
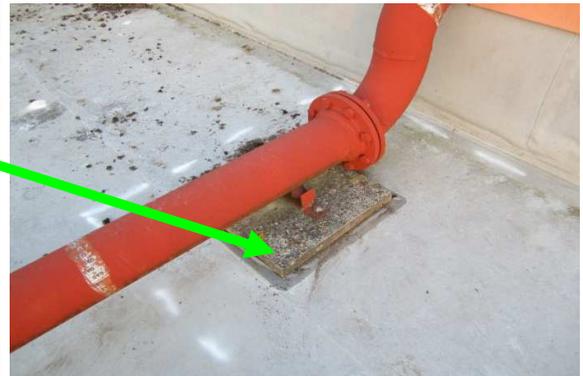
Area: Leak Number 8

The irregular shaped warm area indicates water ingress within the roof system.

The definite source of the moisture could not be located in this area but it is suspected that the stone support base for the gas pipe may have damaged the membrane and should be inspected and re-sealed as required.

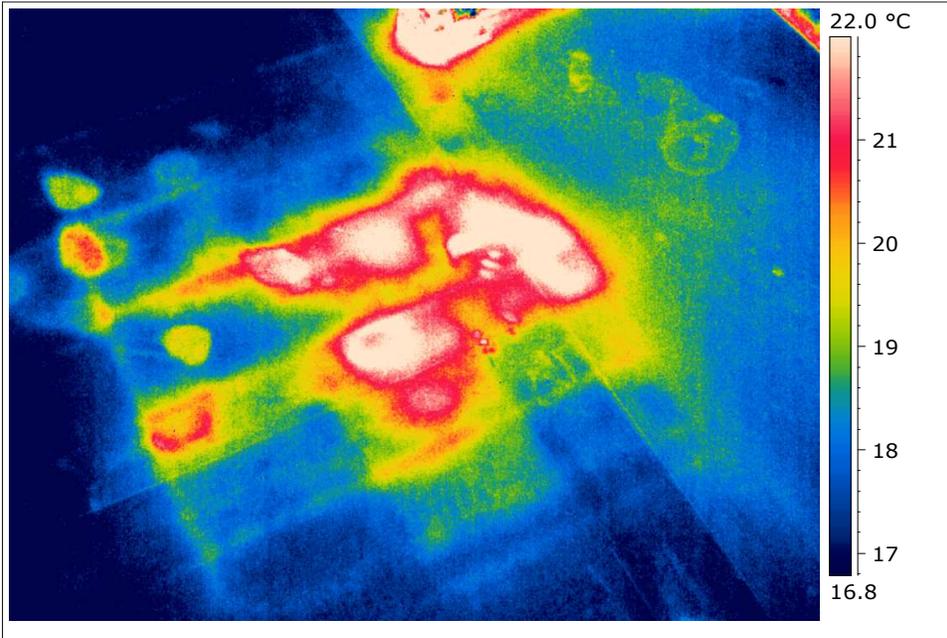
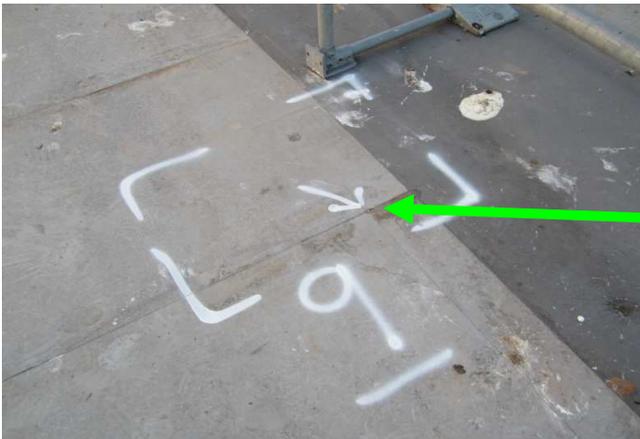
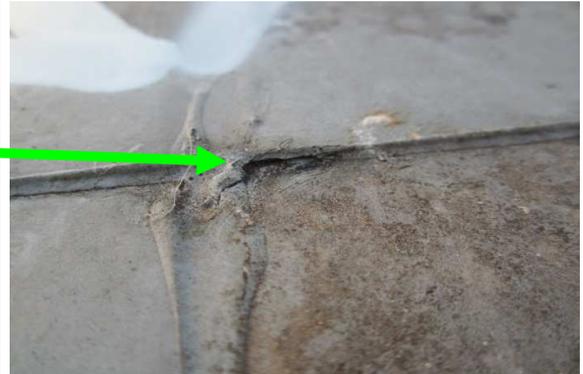
Area: Leak Number 9

The irregular shaped warm area indicates water ingress within the roof system. Closer visual inspection revealed a defective seal in the membrane (arrowed) which is the likely entry point for moisture and should be repaired.

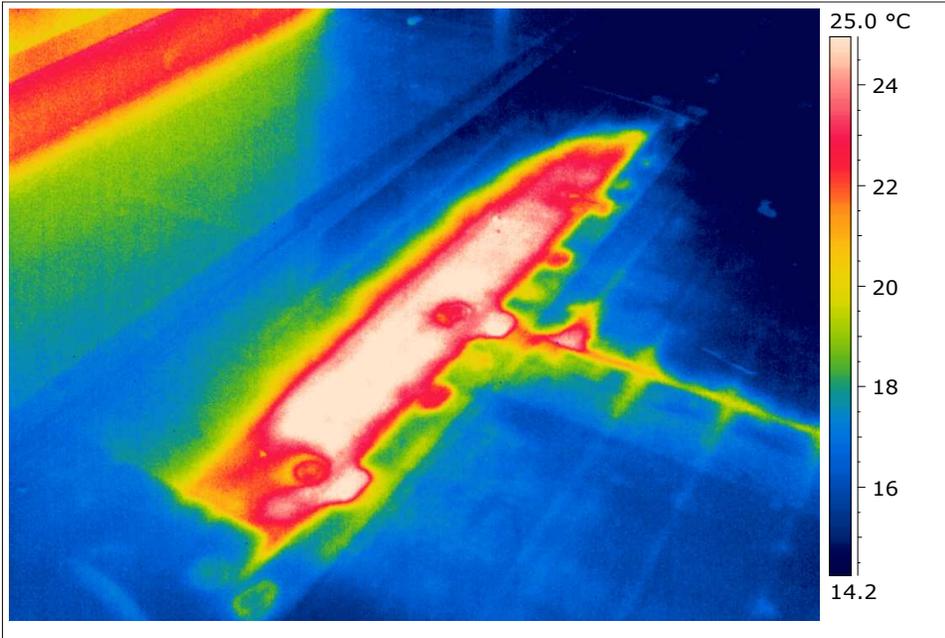
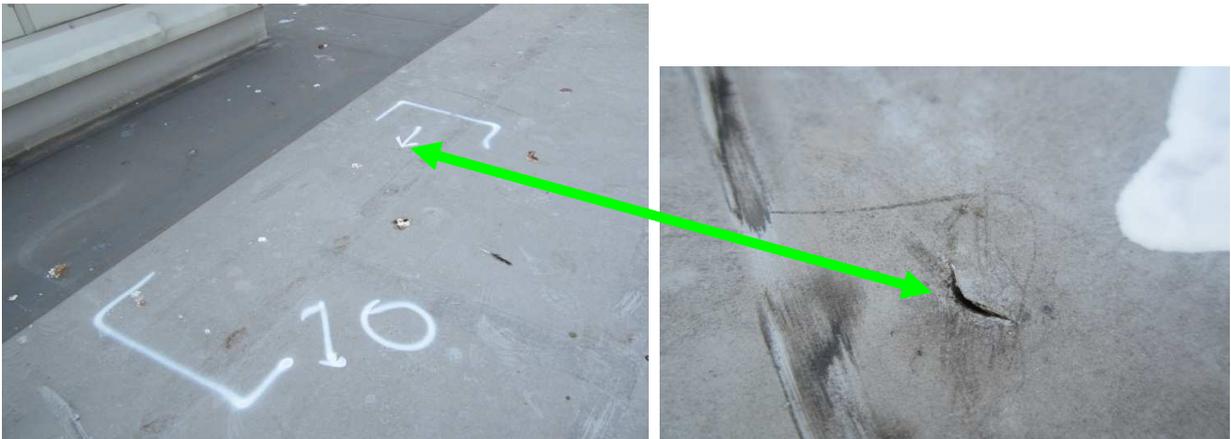
Area: Leak Number 10

The irregular shaped warm area indicates water ingress within the roof system. Closer visual inspection revealed a penetration in the membrane (arrowed) which is the likely entry point for moisture and should be repaired.

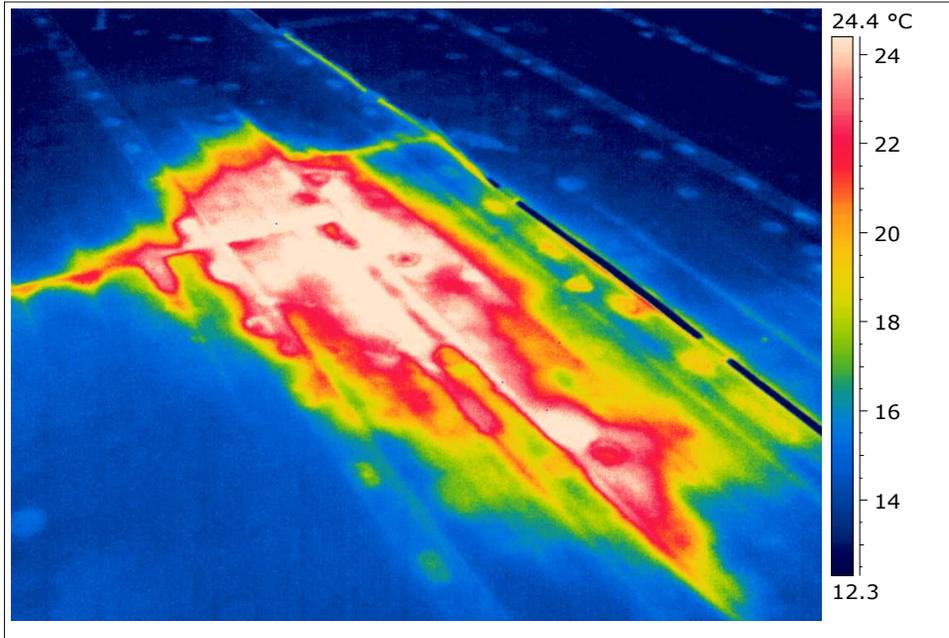
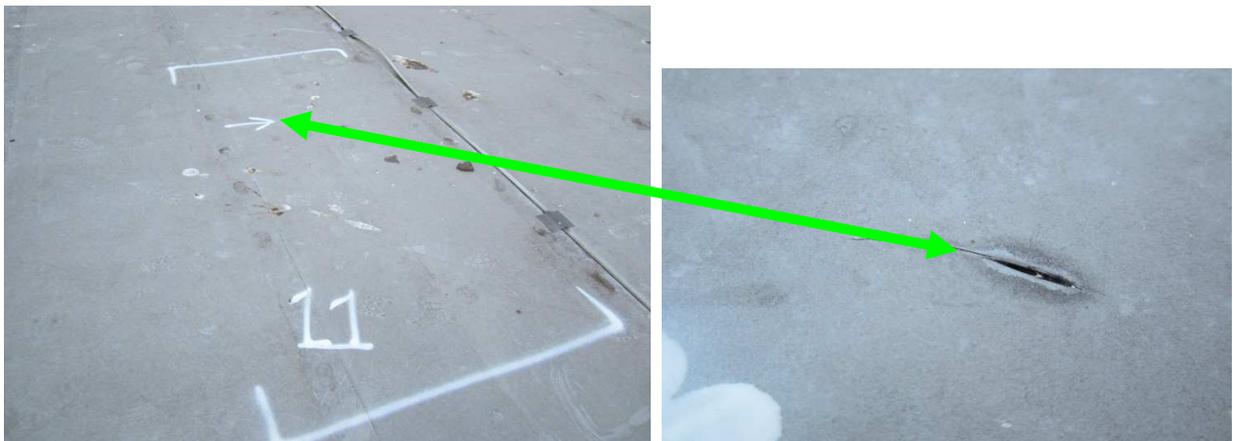
Area: Leak Number 11

The irregular shaped warm area indicates water ingress within the roof system. Closer visual inspection revealed a slit in the membrane (arrowed) which is the likely entry point for moisture and should be repaired.

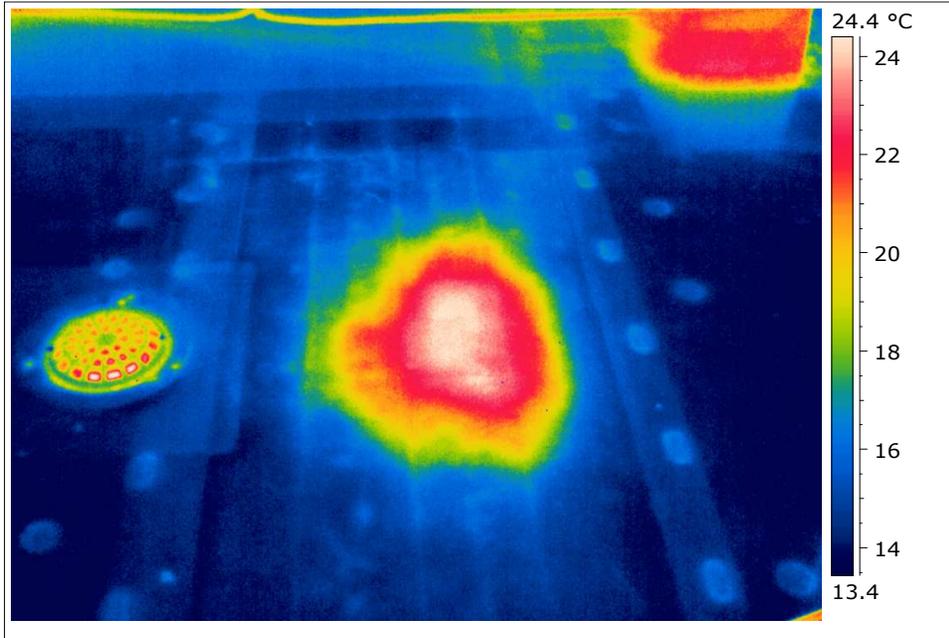
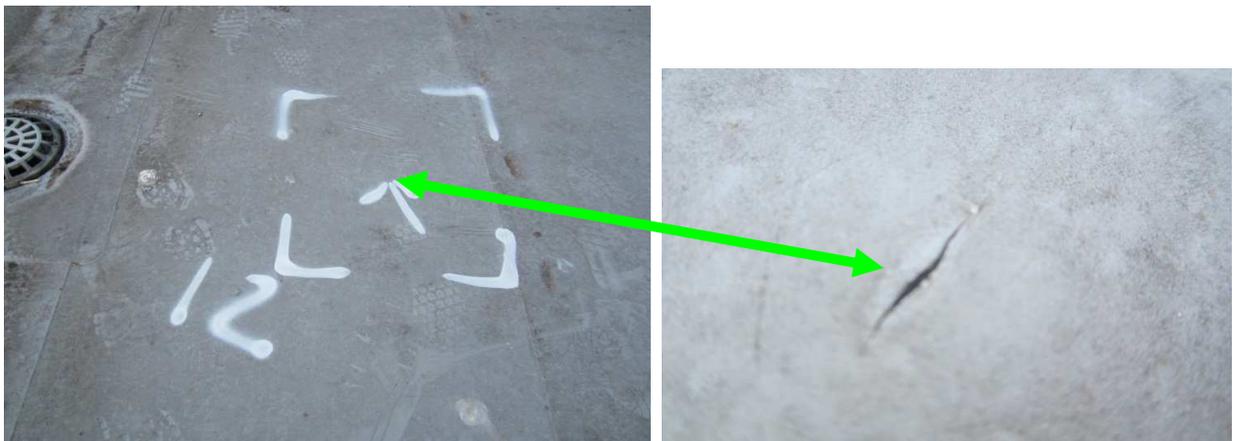
Area: Leak Number 12

The irregular shaped warm area indicates water ingress within the roof system. Closer visual inspection revealed a slit in the membrane (arrowed) which is the likely entry point for moisture and should be repaired.

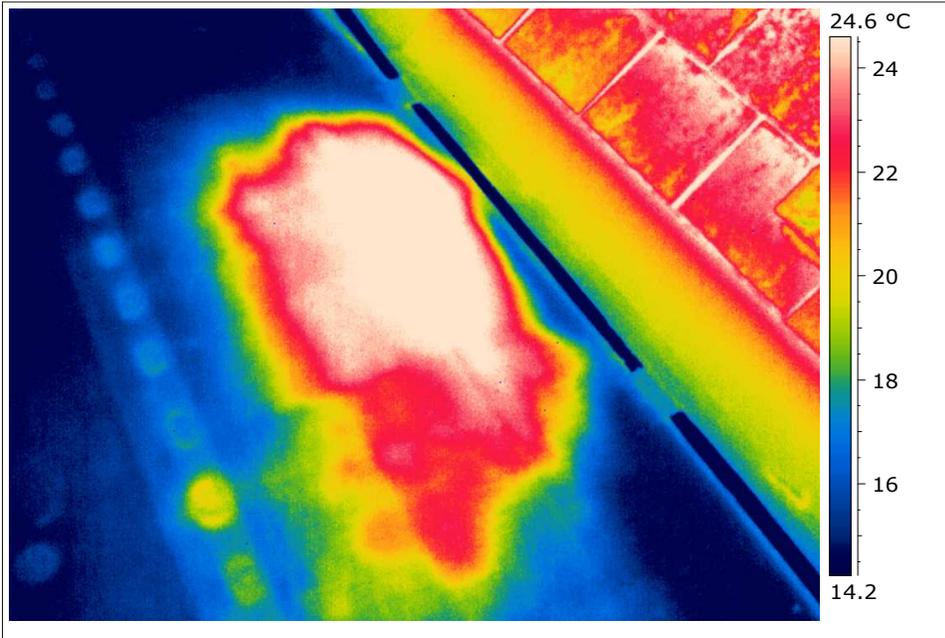
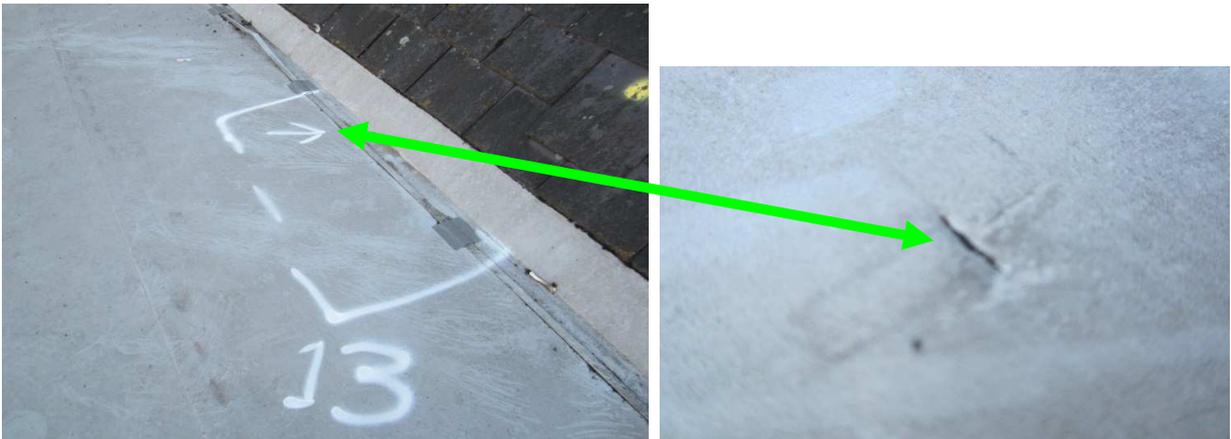
Area: Leak Number 13

The irregular shaped warm area indicates water ingress within the roof system. Closer visual inspection revealed a slit in the membrane (arrowed) which is the likely entry point for moisture and should be repaired.

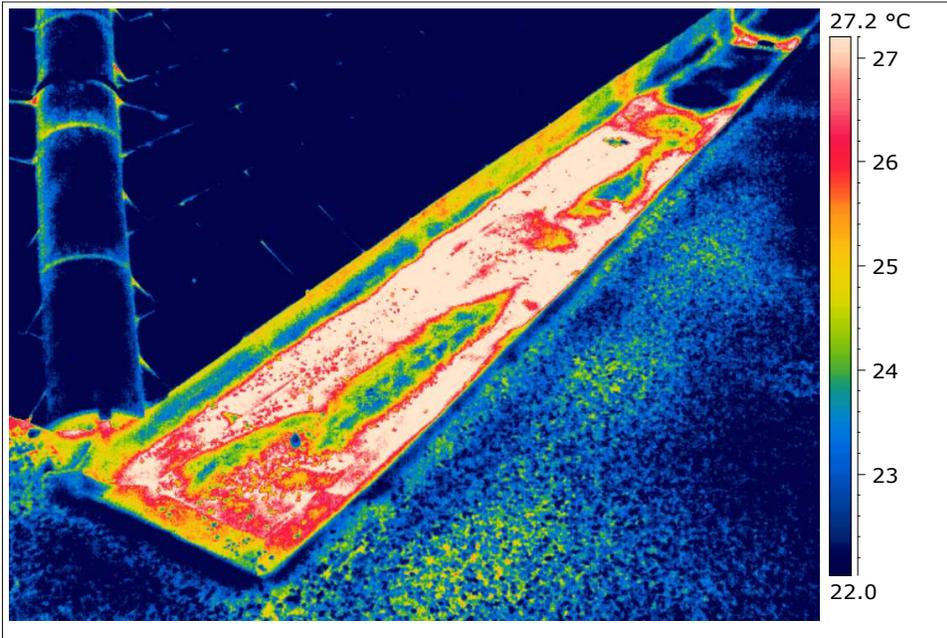
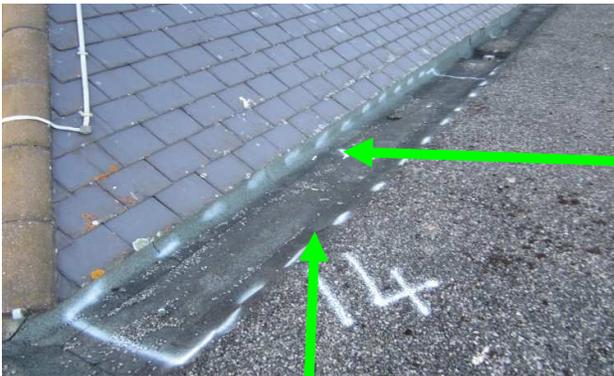
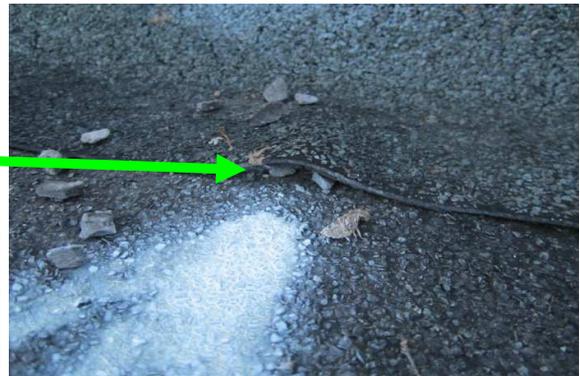
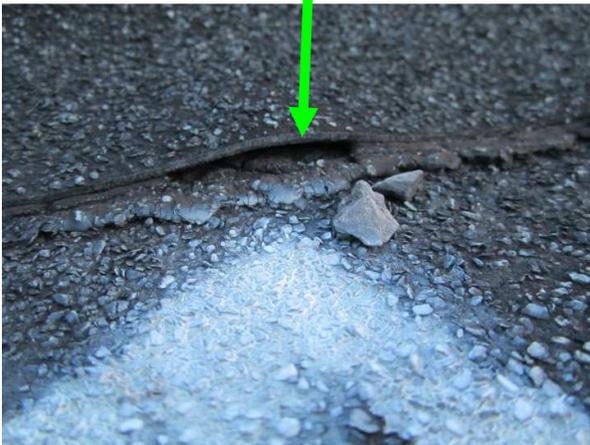
Area: Leak Number 14

The irregular shaped warm area in the gully indicates water ingress within the roof system. Closer visual inspection revealed a suspected defective seal on the felt lap (arrowed) which is the likely entry point for moisture and should be repaired.

The whole area outlined in paint should be thoroughly inspected for any further defects

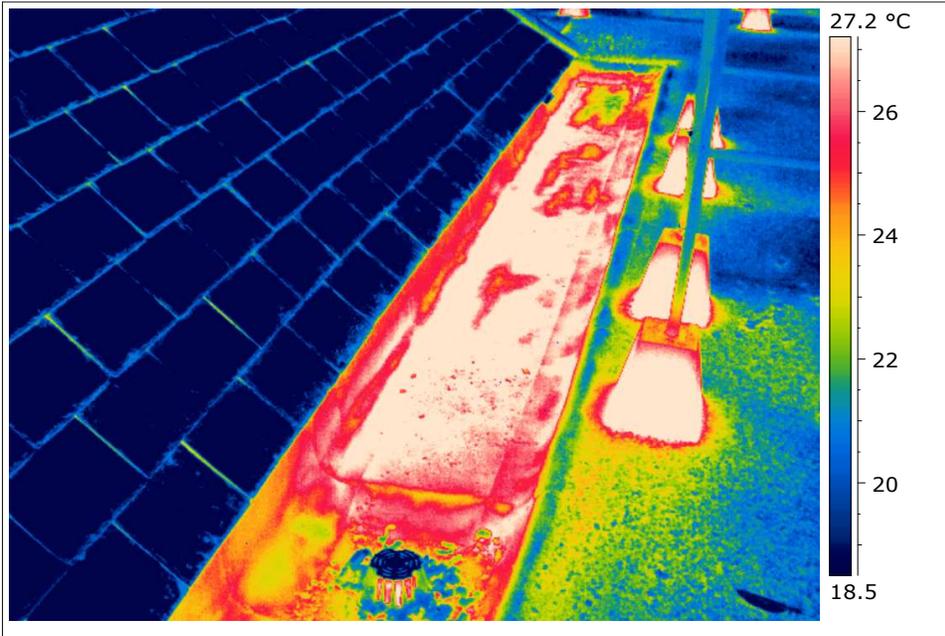
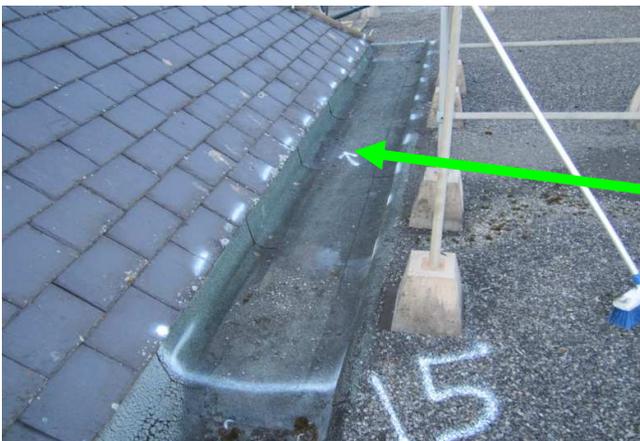
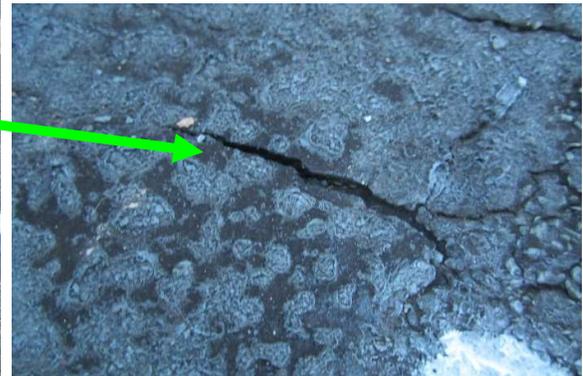
Area: Leak Number 15

The irregular shaped warm area in the gully indicates water ingress within the roof system.

Closer visual inspection revealed a crack in the felt system (arrowed) which is the likely entry point for moisture and should be repaired.

The whole area outlined in paint should be thoroughly inspected for any further defects

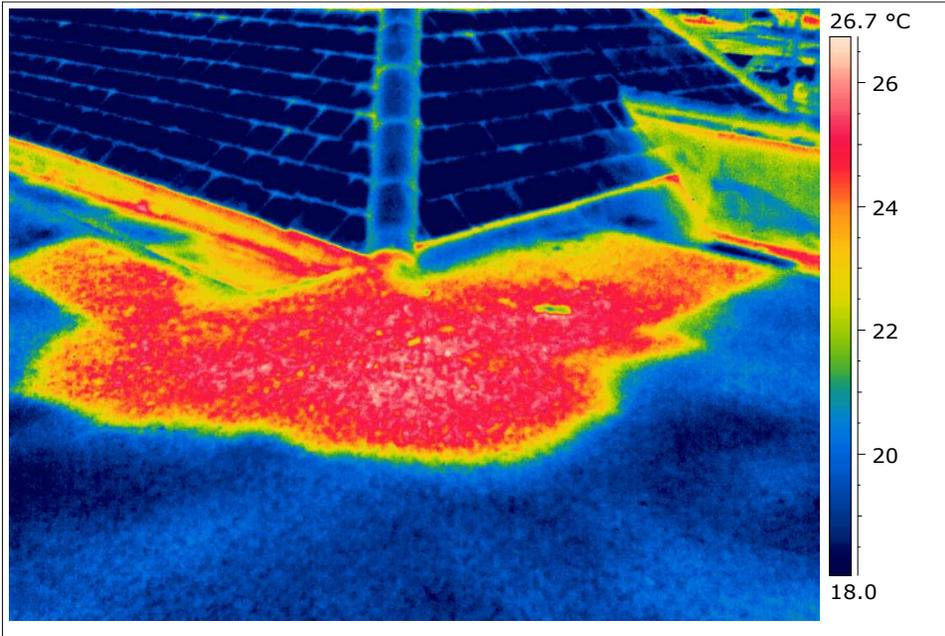
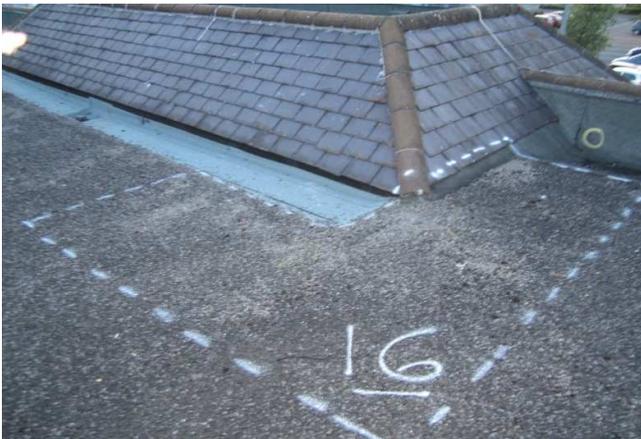
Area: Leak Number 16

The irregular shaped warm area indicates water ingress within the roof system.

Closer visual inspection did not reveal any clear damage although a detailed inspection of the whole area outlined in paint should be thoroughly carried out to identify the water ingress point which will be in this area.

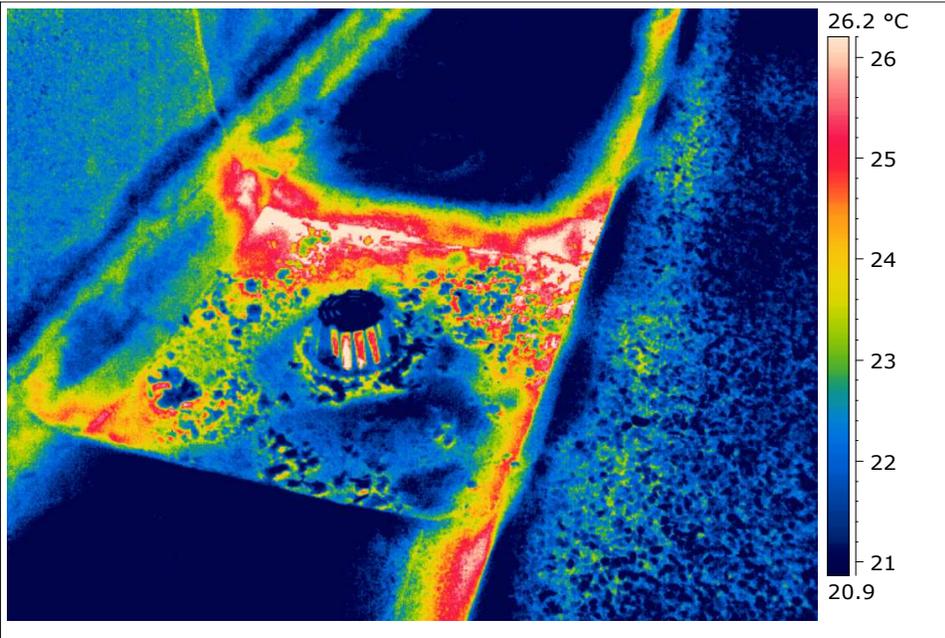
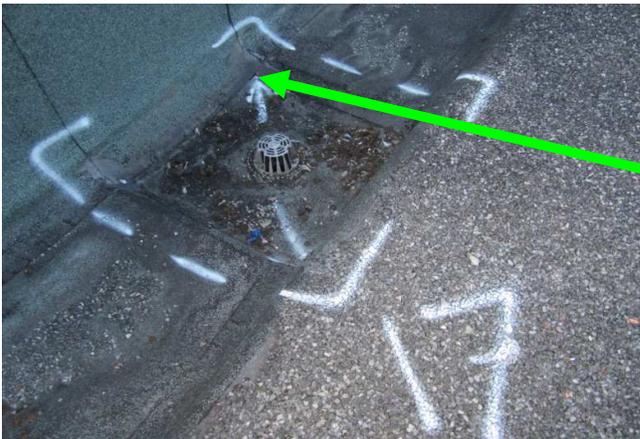
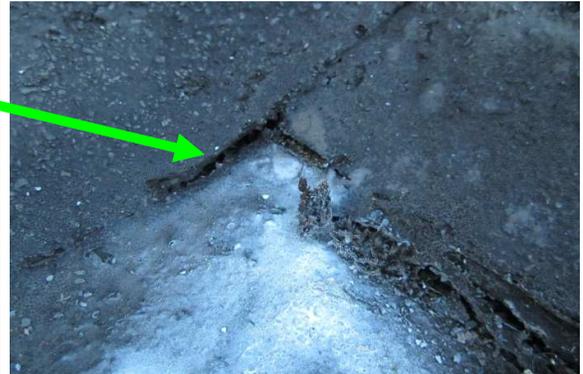
Area: Leak Number 17

The irregular shaped warm area in the gully indicates water ingress within the roof system.

Closer visual inspection revealed a crack in the felt system (arrowed) which is the likely entry point for moisture and should be repaired.

The whole area outlined in paint should be thoroughly inspected for any further defects

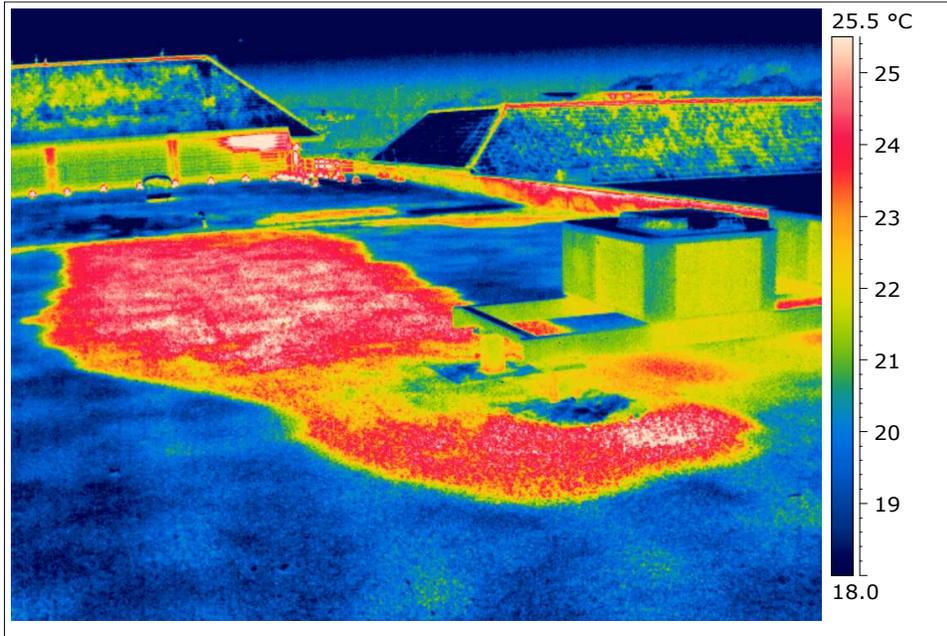
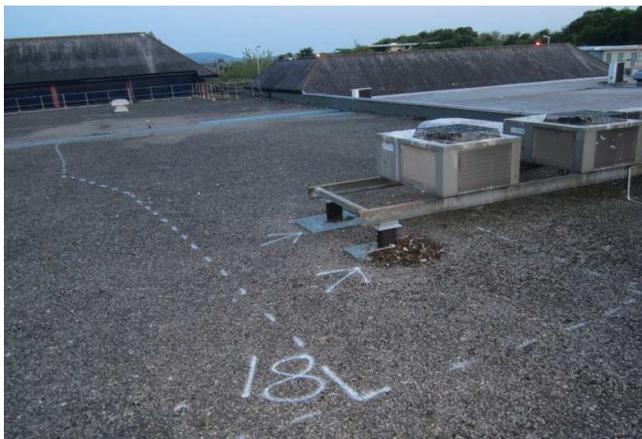
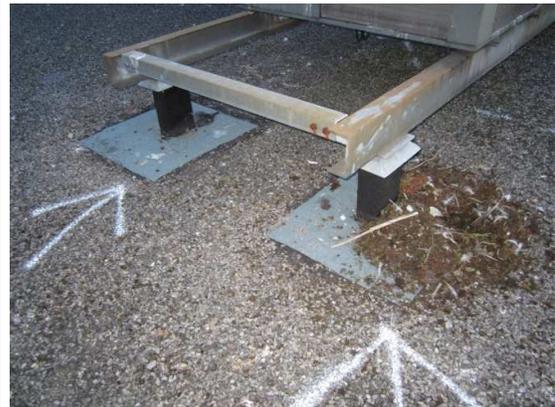
Area: Leak Number 18

The very significant irregular shaped warm area on the roof indicates water ingress within the roof system. Closer visual inspection did not reveal any clear damage although it is suspected that the water ingress is occurring on the two support legs (shown in separate image) above. This area should be thoroughly inspected for any damage.

It should be noted that the water ingress entering at this point appears to then travel down the roof towards the gully in the distance.
