Thermographic Roof Survey

Sample Report

Pixel Thermographics Ltd

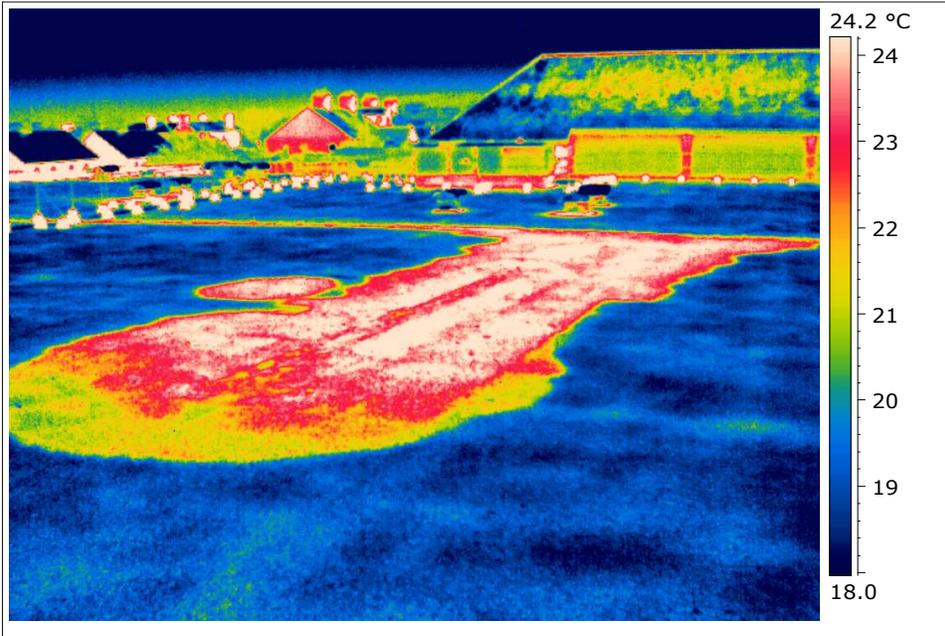
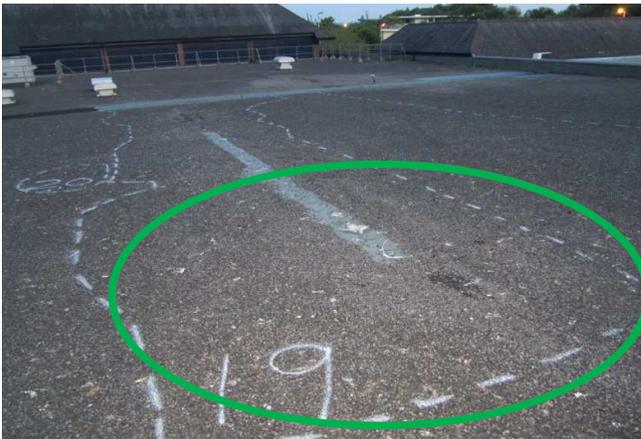
Area: Leak Number 19

The very significant irregular shaped warm area on the roof indicates water ingress within the roof system. Closer visual inspection did not reveal any clear damage although it is suspected that the water ingress is occurring in the area circled in the main photograph and the area should be thoroughly inspected for any damage.

It should be noted that the water ingress entering at this point appears to then travel down the roof towards the gully in the distance.

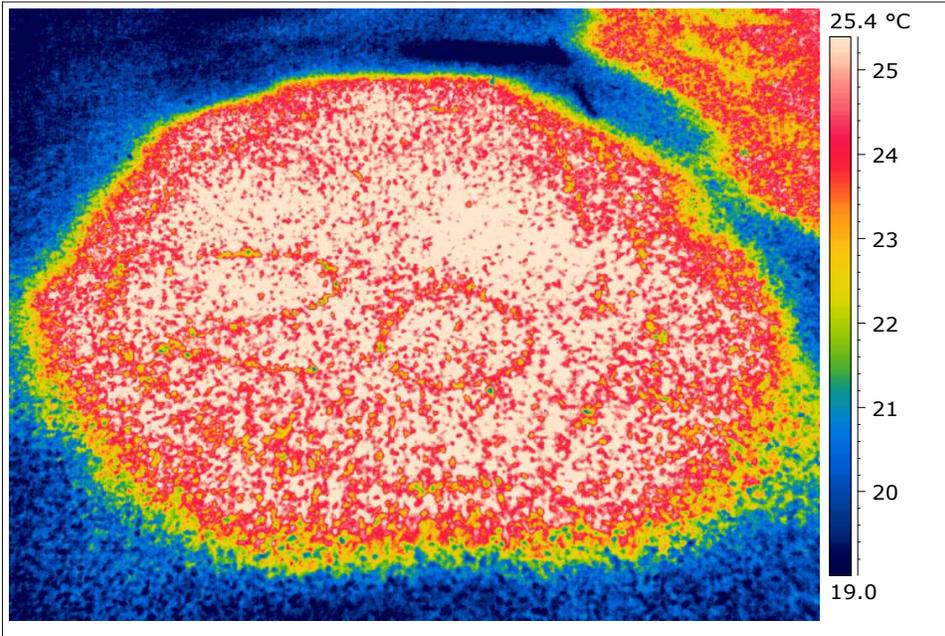
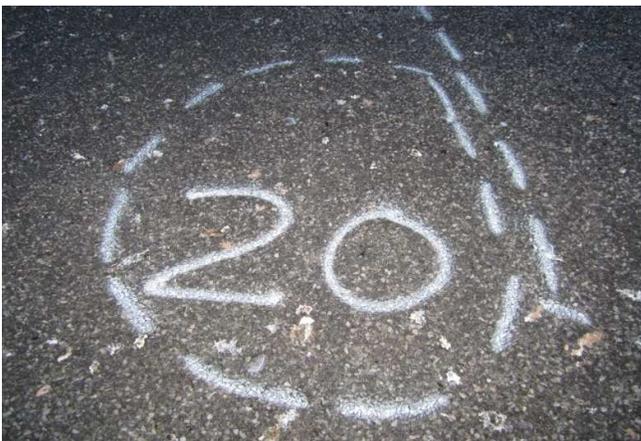
Area: Leak Number 20

The irregular shaped warm area on the roof indicates water ingress within the roof system. Closer visual inspection did not reveal any clear damage so the area encircled in paint should be thoroughly inspected for any damage.

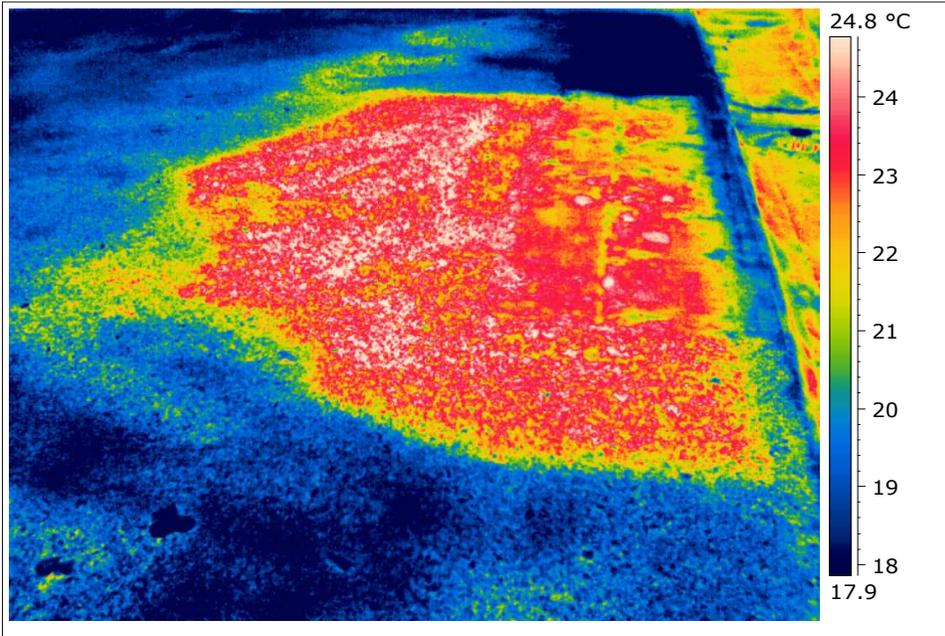
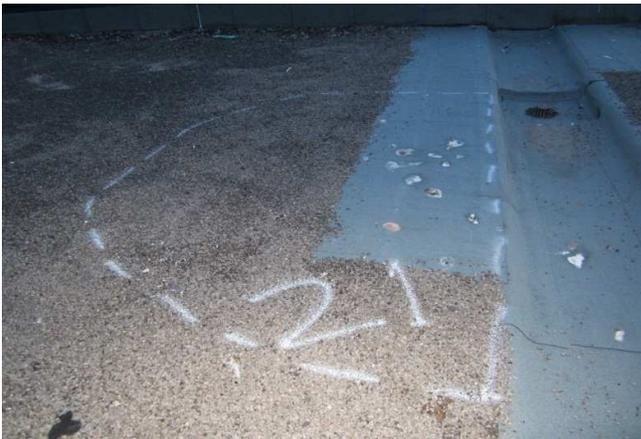
Area: Leak Number 21

The irregular shaped warm area on the roof indicates water ingress within the roof system. Closer visual inspection did not reveal any clear damage so the area encircled in paint should be thoroughly inspected for any damage.

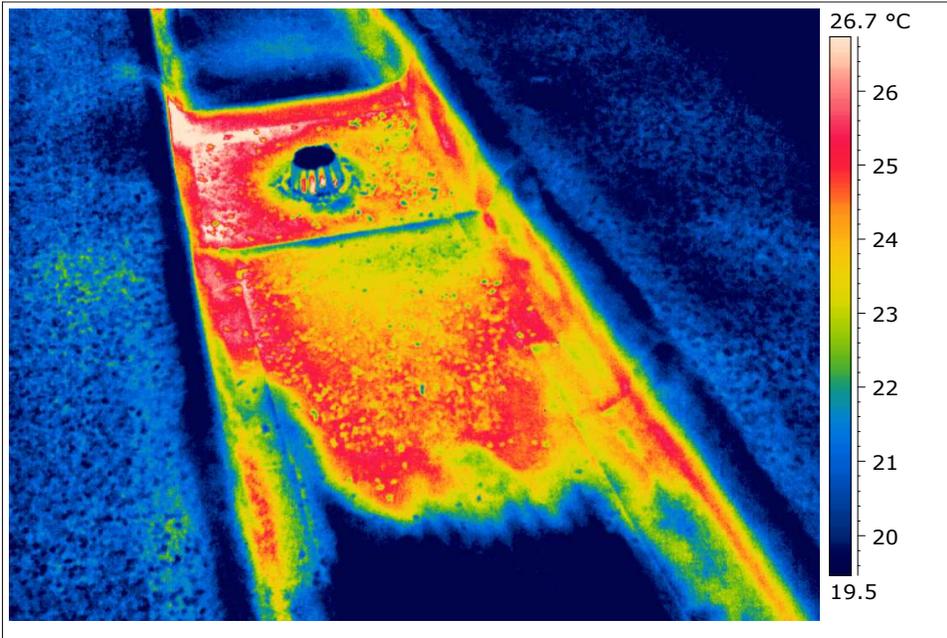
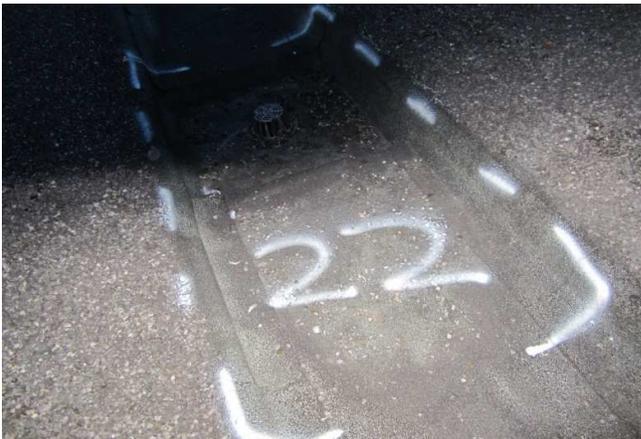
Area: Leak Number 22

The irregular shaped warm area in the gully indicates water ingress within the roof system. Closer visual inspection did not reveal any clear damage so the area encircled in paint should be thoroughly inspected for any damage.
